Square D Inspections, PLLC

Property Inspection Report

123 Sample Report, Central, TX 12345
Inspection prepared for: Steve & Pam Demny
Date of Inspection: 2/6/2018 Time: 9:00 am
Age of Home: 2012 Size: 2250
Weather: 74* Sunny
Inspector: Stephen C. Demny

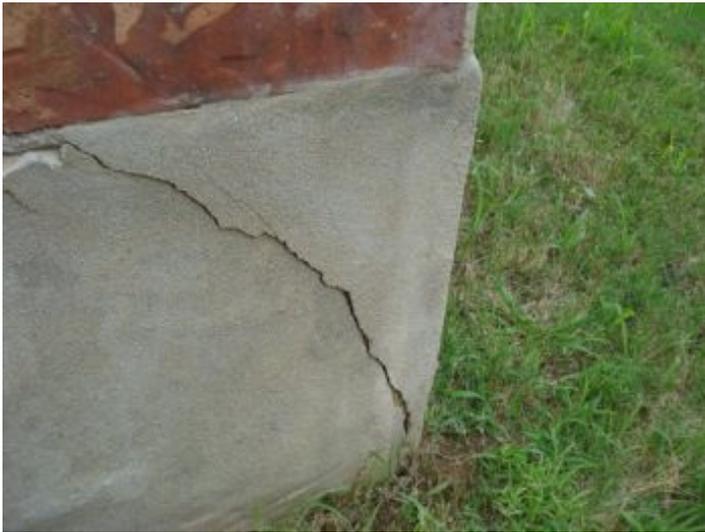
- In my opinion, this foundation does appear to be satisfactorily performing the function for which it is intended at the time of inspection. This is not an engineering report, but is only an opinion based on my observation of conditions known to be related to foundation performance.
- Note: Corner pops were observed on the exterior of the foundation.
- Dirt was observed to be too high on the foundation for drainage and almost touching the masonry or stone. It is recommended to have at least 4" exposed.
- **Dirt was observed to be too high on the foundation for drainage and almost touching the masonry or stone. It is recommended to have at least 4" exposed.**
- **Cable ports on post tension foundations should be sealed with mortar.**

Corner pop observed

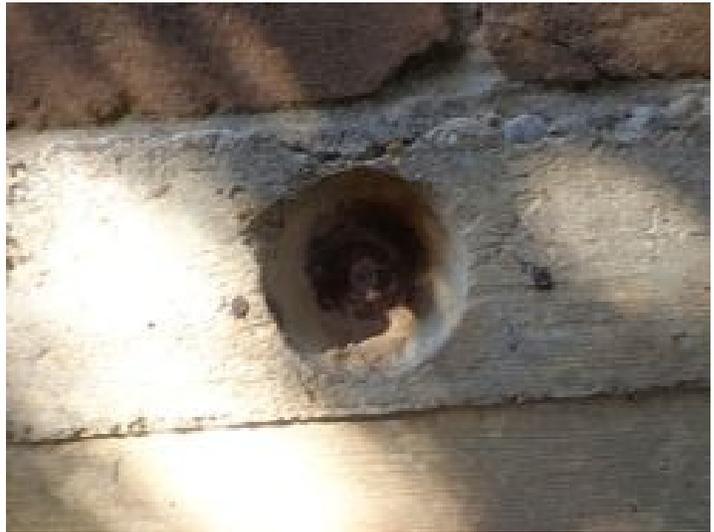
Exposed tendon cable

Page 4 Item: A	Foundations	<ul style="list-style-type: none"> • Dirt was observed to be too high on the foundation for drainage and almost touching the masonry or stone. It is recommended to have at least 4" exposed. • Cable ports on post tension foundations should be sealed with mortar.
Page 5 Item: B	Grading and Drainage	<ul style="list-style-type: none"> • Evidence of water pooling/standing was observed in the front and/or back flower bed areas. Allowing water to pool against the home is not recommended as this can encourage movement in the foundation of the home. Recommend landscape technician for further evaluation and improvements to the grading and drainage in the flower beds. • The grade (soil/ground covering) was observed to be above the slab on the rear side of the home. This is not recommended as it can cause moisture and pest intrusion into the home. • Gutters are not performing as intended and diverting water away from the structure.

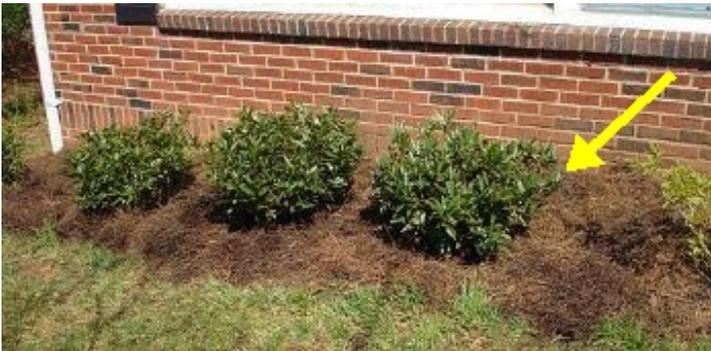
- **Evidence of water pooling/standing was observed in the front and/or back flower bed areas. Allowing water to pool against the home is not recommended as this can encourage movement in the foundation of the home. Recommend landscape technician for further evaluation and improvements to the grading and drainage in the flower beds.**
- **The grade (soil/ground covering) was observed to be above the slab on the rear side of the home. This is not recommended as it can cause moisture and pest intrusion into the home.**
- **Gutters are not performing as intended and diverting water away from the structure.**

Landscape soil above brick ledge

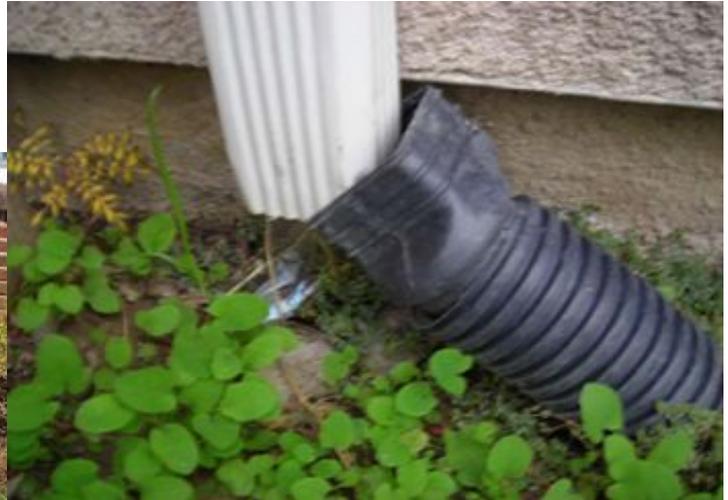
Gutter downspout connection

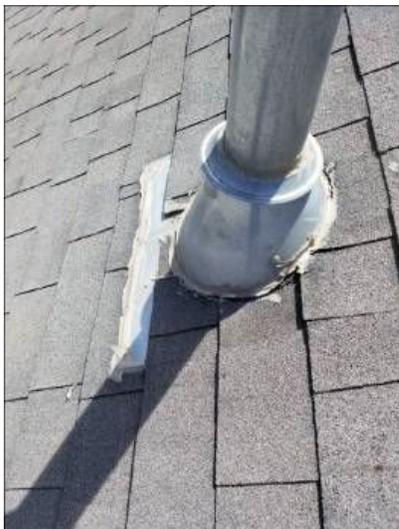
- The roof covering appears to be performing as intended at the time of the inspection.
- Note: There are exposed nail heads in various areas around the roof. Recommend weather sealing the exposed nail heads to help prevent moisture intrusion in the roofing system.
- Note: Plastic vents protruding from the roof should be painted to protect them from UV damage. All vent penetrations should be sealed and caulked.
- The roof covering was observed to be in contact with tress branches. Recommend licensed landscape contractor to trim branches 12" away from roof.

Recommend Caulking

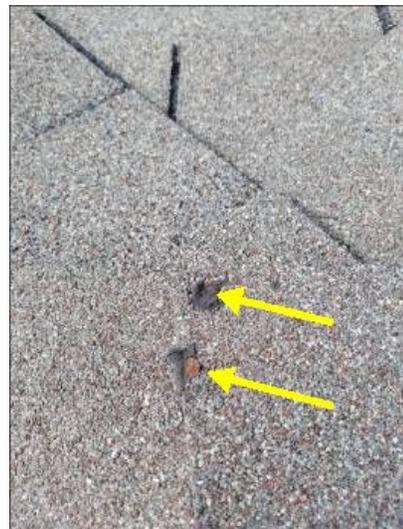
Exposed Nails

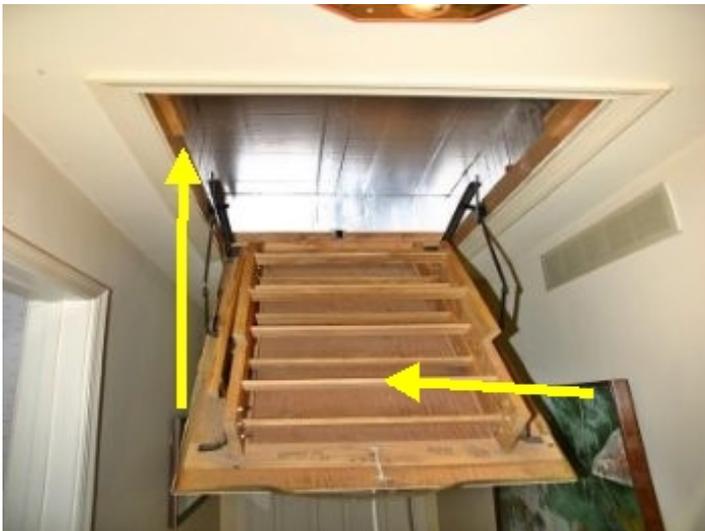
- The attic ladder comes as a built in item, it is recommended to insulate the attic ladder drop down hatch if it is installed in a controlled environment.
- Note: The inspector was unable to access the entire attic space due to limited room for movement. As a result, the inspector could not visually inspect all areas of the attic including roof, decking, framing, insulation, ceiling framing, and electric.
- The attic insulation appears to have been installed over the perimeter soffit vents which are necessary for proper cross ventilation in the attic space.
- **The attic ladder was observed to be installed with improper fasteners. This condition should be further evaluated and corrected as necessary for safety concerns.**

Mounting hardware and Insulation

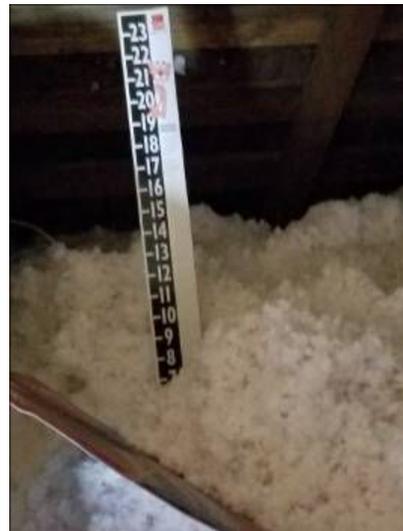
Insulation Depth

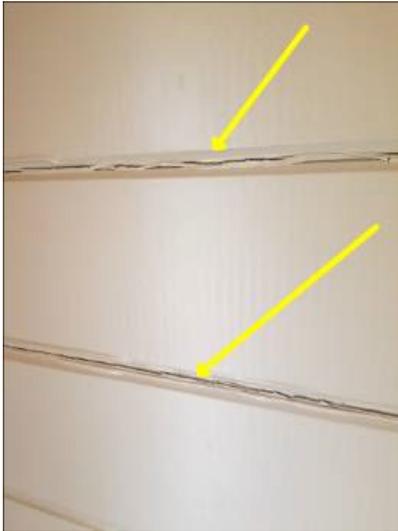
- Some of the wood trim showing signs of wear and moisture intrusion in multiple areas around the structure. Recommend sealing and repainting these areas around the house to prevent moisture intrusion. This includes the various areas of fascia and some areas of the soffit.
- Minor cracks were observed in brick and mortar joints along the exterior side of the home. Expansion joints were not observed, which may contribute to this condition.
- Multiple cracks were observed on the interior walls throughout the home in various areas.

Caulking Recommended

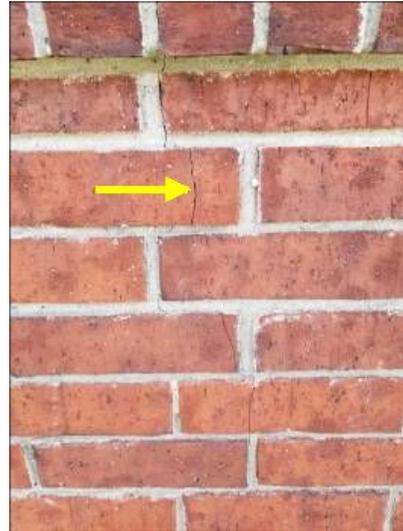
Missing Expansion Joint Minor Cracks

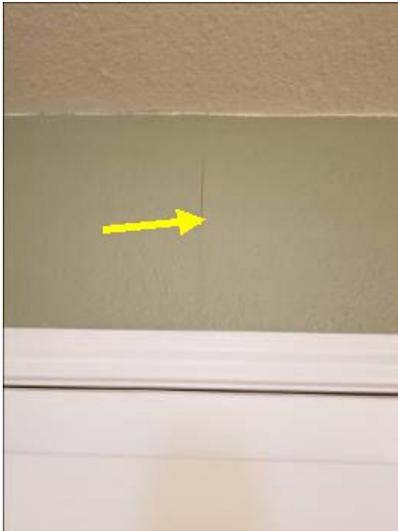
Minor Crack

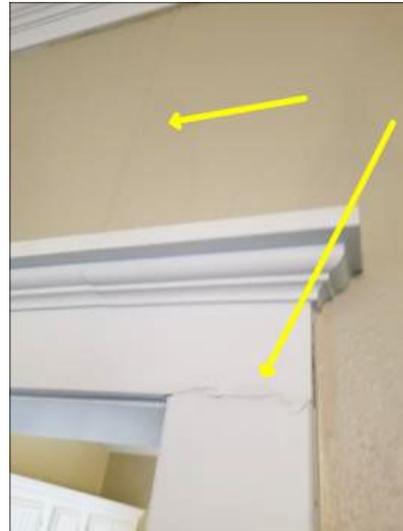
Minor Settlement

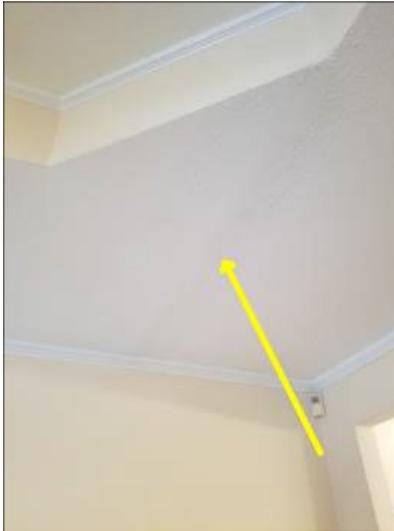
- A crack was observed in the drywall on the ceiling of the living room.
- All ceilings and floors appeared to be functional at the time of inspection.

Previous Ceiling Repair

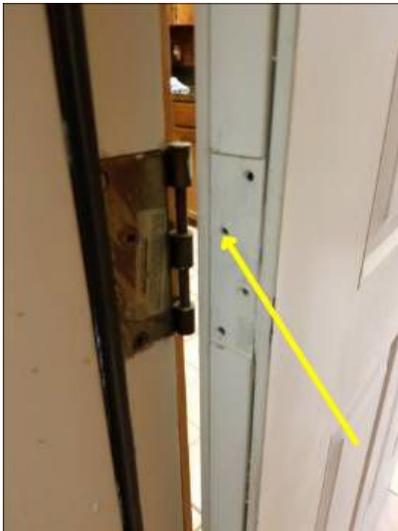
- Door hardware is missing in one of the doors in the garage to kitchen.
- Double cylinder locks were observed in one or more locations at the egress doors. ALL exterior egress doors should be readily operable from the interior side without the use of a key or special effort and/or knowledge as per current fire safety standards
- There are cracked and/or loose glass panes observed in the front door.
- **The door casing and jamb were observed to be rotted at the base of a door on the rear exterior side of the home.**

Missing Hardware

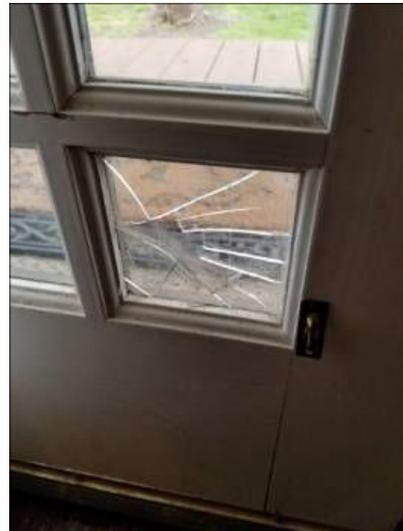
Cracked Glass

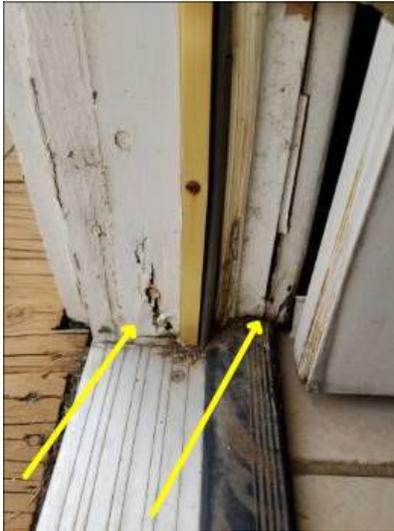
Water Damage

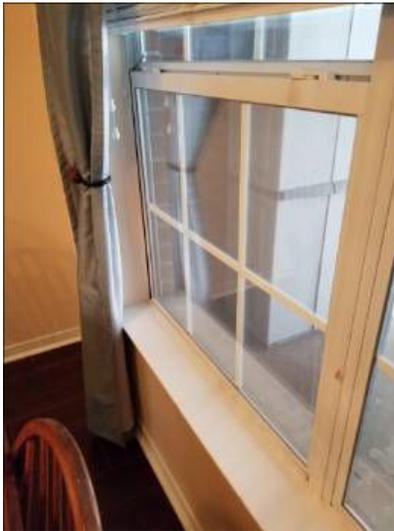
- All windows were found to be functional at the time of the inspection.
- Some window screens on the exterior side of the home are damaged.

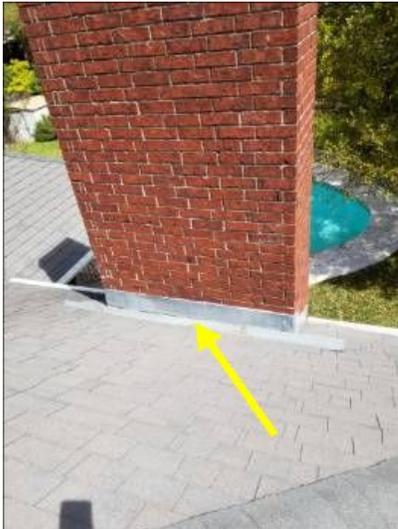
- The fireplace extending through the roof was observed to be missing the recommended cricket or saddle type flashing that is installed on wide chimneys to divert water around the chimney during rains.
- There is no permanently mounted fireplace screen on the wood burning fireplace. It is recommended that a screen be permanently installed for all wood burning fireplaces.
- **The opening was observed to be to close to the wall surface or combustible materials.**

Cricket Recommended

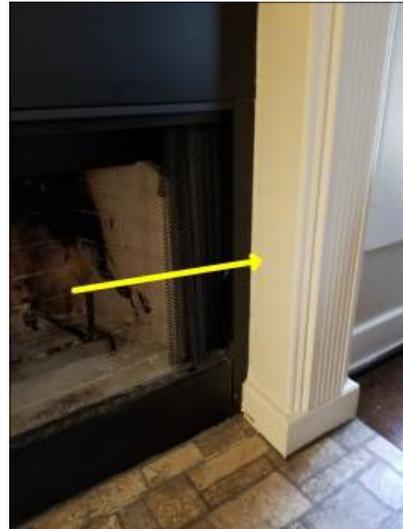
Wood Combustible

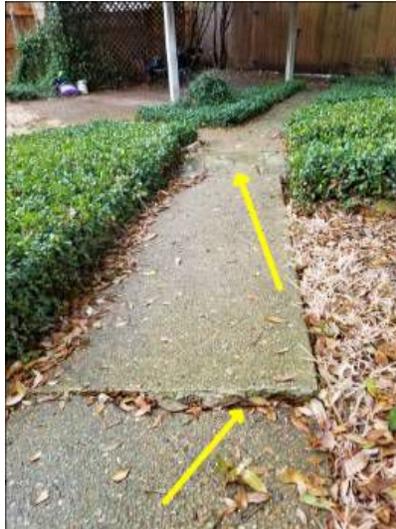
- The sidewalks have settlement and/or movement cracks which is a trip and safety hazard.

Sidewalk Trip Hazard

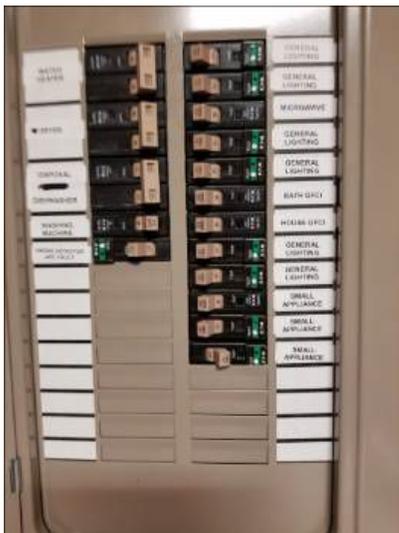
- The electric panel is located on an exterior wall of the home. All electricity to the home can be shut off with 1 throw, or one switch of the main breaker which is rated at 200 AMPS.
- Service entrance wiring is underground.
- One of the breakers in the main panel was in the off position. Inspector did not turn the breaker on. Recommend a licensed electrician inspect the panel as well as verify the breaker turned to the off position.
- One of the breakers in the electric panel has been double tapped (2 wires in a breaker port, designed for only 1 wire), which is not recommended practice. Recommend a licensed electrician for further evaluation of the electrical panel.

Sub Panel Labeling

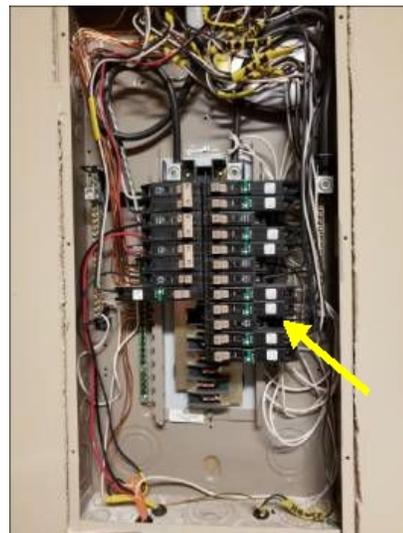
Double Lugging

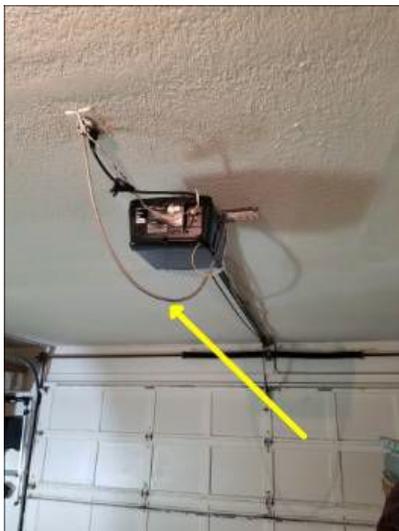
Extension Cord

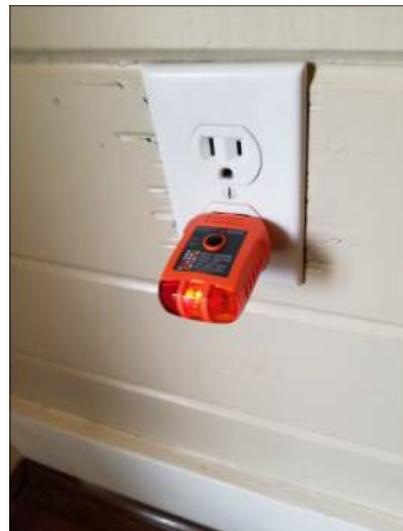
Open Ground Connection

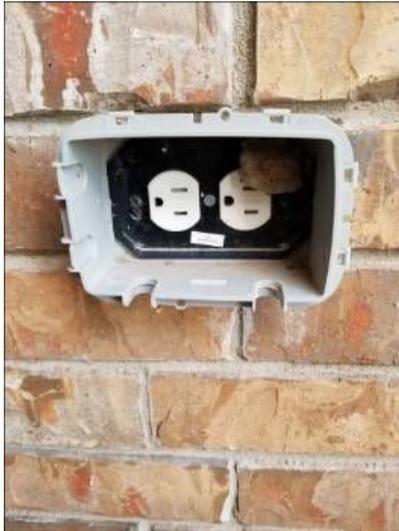
- The outlets in the garage are not believed to be **GFCI** protected.
- Doorbell functions normally.
- Note: Some of the exterior outlets are missing the recommended bubble type exterior cover.
- Multiple outlets in the home have an open ground.
- **Smoke and/or carbon monoxide detectors were found to be missing in recommended areas of the home. It is recommended that smoke detectors be placed in every sleeping area, outside the sleeping areas, and on every story of the home including basements and habitable attics. It is also recommended that carbon monoxide detectors be placed outside each sleeping area in homes with fuel fired appliances or attached garages.**

Missing Bubble Cover

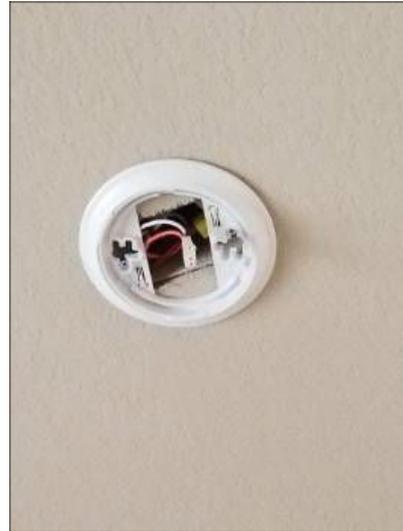
Missing Smoke Alarm

Page 13 Item: B	Branch Circuits, Connected Devices, and Fixtures	<ul style="list-style-type: none"> • Smoke and/or carbon monoxide detectors were found to be missing in recommended areas of the home. It is recommended that smoke detectors be placed in every sleeping area, outside the sleeping areas, and on every story of the home including basements and habitable attics. It is also recommended that carbon monoxide detectors be placed outside each sleeping area in homes with fuel fired appliances or attached garages.
-----------------	--	---

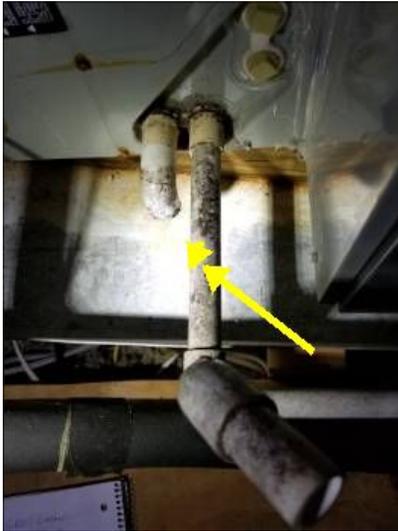
- Rust and/or corrosion was noted in the condensate drip pan.
- Condensate drain line was missing insulation at the unit.

Missing Insulation

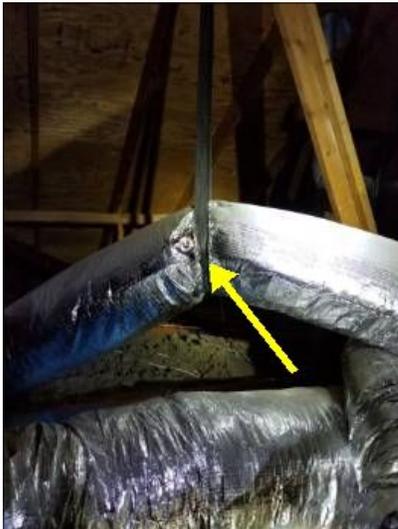
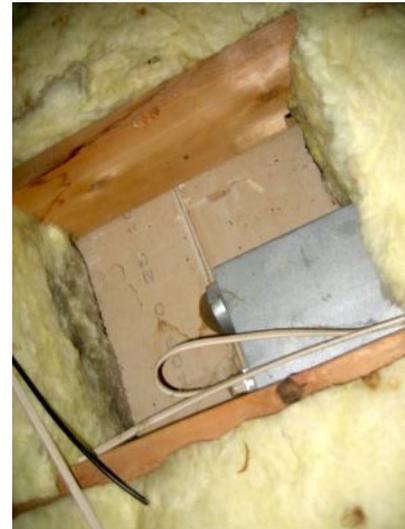
- Some of the ductwork was observed to have more than 90* degree bends which prohibit proper airflow and and unbalanced air system.
- The return air filter is dirty and should be replaced.
- The bathroom vent does not extend to exterior air and terminates in the attic. Vents are disconnected and/or improperly installed.

Bathroom Exhaust Vent

- The bath fans were observed to be vented in the attic space. Recommend installing vent pipe and terminate to the exterior through the roof to remove moisture and CO2 gases.

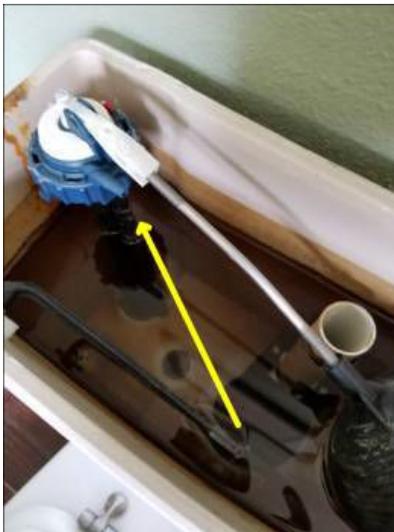
- Comments:
- The sink drain in the master bathroom is draining slowly. Recommend licensed plumber for further evaluation.
 - The water fill tubing was missing and 1" **air gap** is required on toilet fill valve.
 - The bathtub in the master bathroom is draining slowly. Recommend licensed plumber for further evaluation.

Missing 1" Air Gap tubing

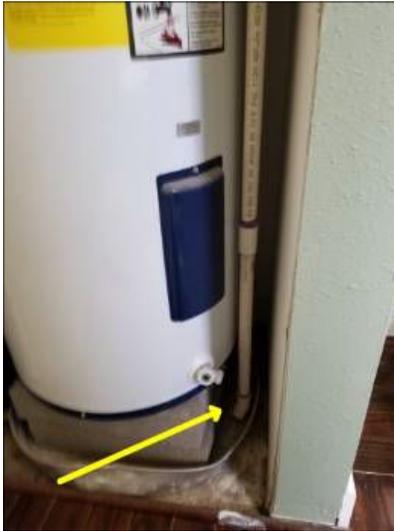
- Energy Source:
- Electric
- Capacity:
- Unit is 50 Gallons
- Comments:
- The water heater in the bath closet appeared to be functioning properly at the time of inspection.
 - The **TPR valve** piping discharge line should terminate to the outside above the finished grade and remain uncapped. We found the existing piping to terminate at the drain pan inside the closet.

TPR piping

Page 16 Item: C	Water Heating Equipment	<ul style="list-style-type: none"> • The <u>TPR valve</u> piping discharge line should terminate to the outside above the finished grade and remain uncapped. We found the existing piping to terminate at the drain pan inside the closet.
-----------------	-------------------------	--

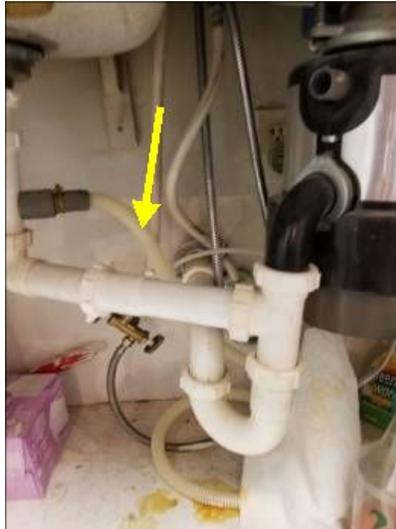
- The dishwasher functioned properly during the inspection.
- No high loop or air gap in the drain line. Recommend securing the drain line to the bottom of the counter in order to prevent waste water and drain line back up into the dishwasher.

No raised Drain Loop

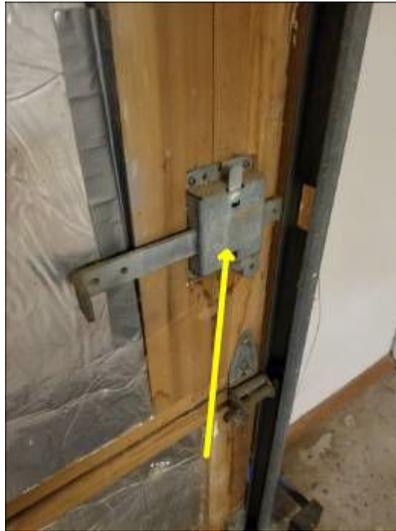
- Garage door and automatic opener functioned normally during the inspection. Note: It is recommended that the lock/latch on the garage doors be removed when an automatic opener is installed.

Remove Manuel Latch

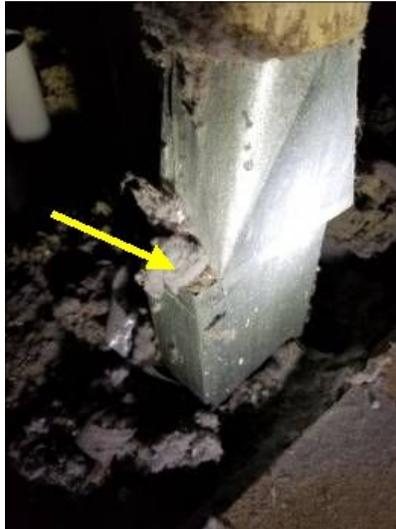
- The dryer vent is a vertical vent that terminates on the roof of the home and was found disconnected in the attic and excessive lent was observed. Note: Vertical dryer vents have a tendency to clog easier which could potentially be a fire hazard. Routine inspections of the dryer vent should be established along with routine cleaning.

Disconnected Dryer Vent

Page 19 Item: H	Dryer Exhaust Systems	<ul style="list-style-type: none"> • The dryer vent is a vertical vent that terminates on the roof of the home and was found disconnected in the attic and excessive lent was observed. Note: Vertical dryer vents have a tendency to clog easier which could potentially be a fire hazard. Routine inspections of the dryer vent should be established along with routine cleaning.
-----------------	-----------------------	---

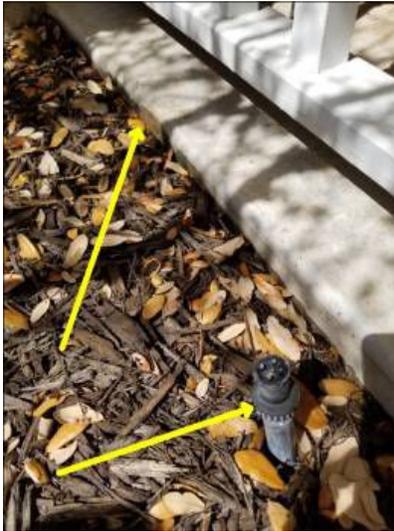
• The sprinkler heads in zone 6 of flower bed was damaged and/or missing during the manual testing of the sprinkler system, allowing water to shoot straight up and not in an even flow pattern. Recommend further evaluation by a professional landscaper.

Leak on Zone 6

Page 20 Item: A	Landscape Irrigation (Sprinkler) Systems	<ul style="list-style-type: none">• The sprinkler heads in zone 6 of flower bed was damaged and/or missing during the manual testing of the sprinkler system, allowing water to shoot straight up and not in an even flow pattern. Recommend further evaluation by a professional landscaper.
-----------------	--	---
